# The Kowloon Collapse

AT 45J MA TAU WAI ROAD  
TO KWA WAN, KOWLOON - K.I.L. 8627  
ON 29 JANUARY 2010

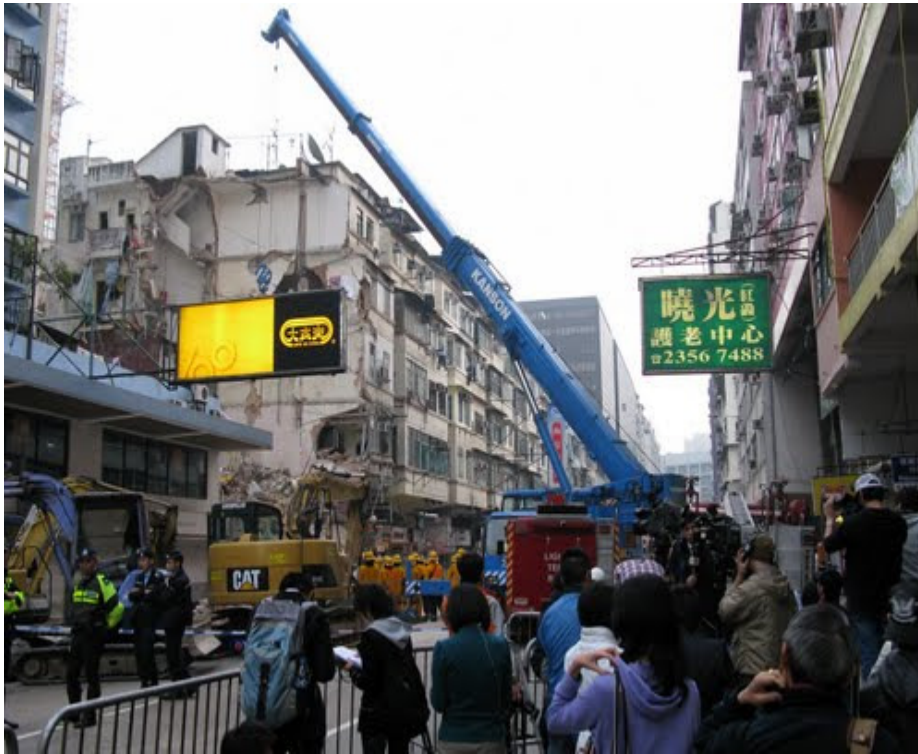
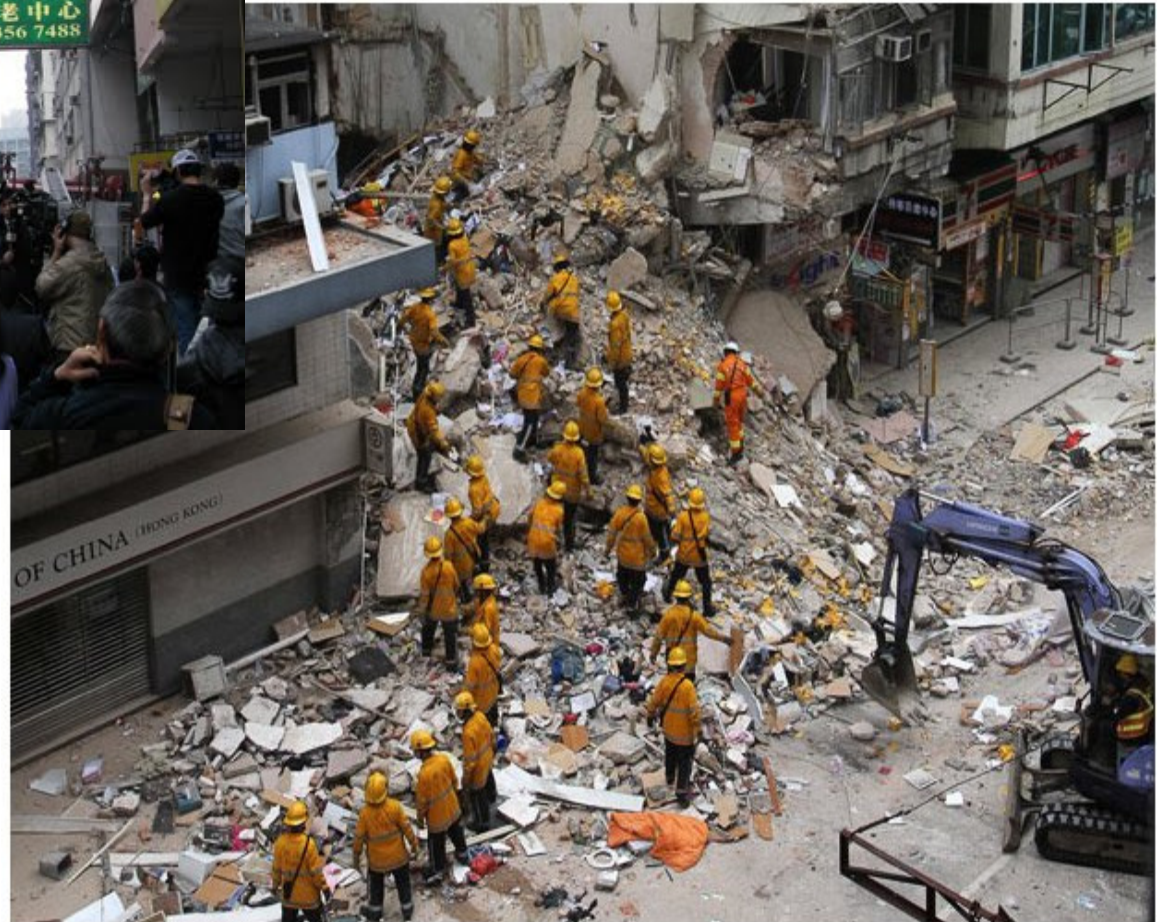
This plot shows the radar return from the building which collapsed in January 2010 (strong signal before Jan, weak signal after)

Accurate location, estimated height: 16m

This plot shows that the building started sinking at the end of June 2009 (~4mm), and had a strong acceleration in Nov 2009 (~8mm).

Altogether, since the beginning of 2009, the total displacement before the collapse was about 20mm

The building at 45j Ma Tau Wai Road, To Kwa Wan, Kowloon was visible from radar images taken by the satellite TerraSAR-X since October 2008.

The interferometric analysis shows that the building started sinking in Summer 2009. Before November 2009, the detected movements were not enough to rise a warning (they could be interpreted as thermal expansion). However, after November 2009 it was clear that the building was affected by a different and stronger process.

The building beside the collapsed one and the ground (street level) do not show significant movements neither before nor after the collapse.
